Inspection Report
Minerals Regulatory Program
April 20, 2011

Mine Name: Torrey Buff	Permit Number: S/055/012
Operator Name: Jon Young	Inspection Date: April 20, 2011
Inspector(s): Wayne Western	Time: 12:15 – 12:55 PM
Other Participants:	Mine Status: Suspended

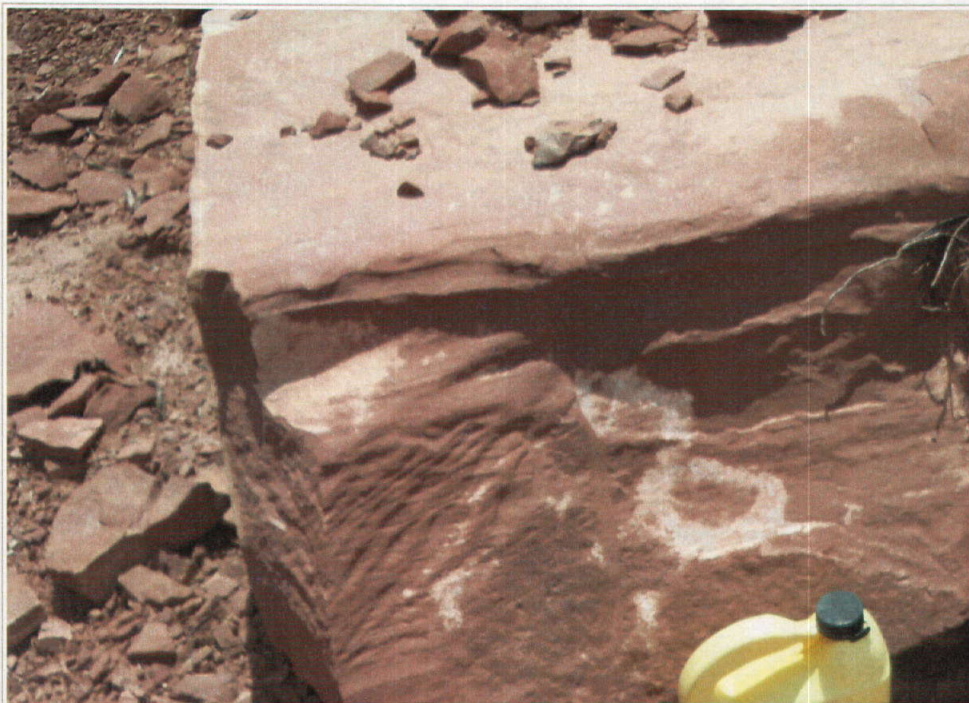
There is what appears to be a jug of antifreeze on the north area and that must be removed. On the south area there is bucket of hydraulic oil that is full and needs to be removed.

Jug of what appears to be antifreeze

The Division should require the Operator to clean up the site and remove all deleterious materials.

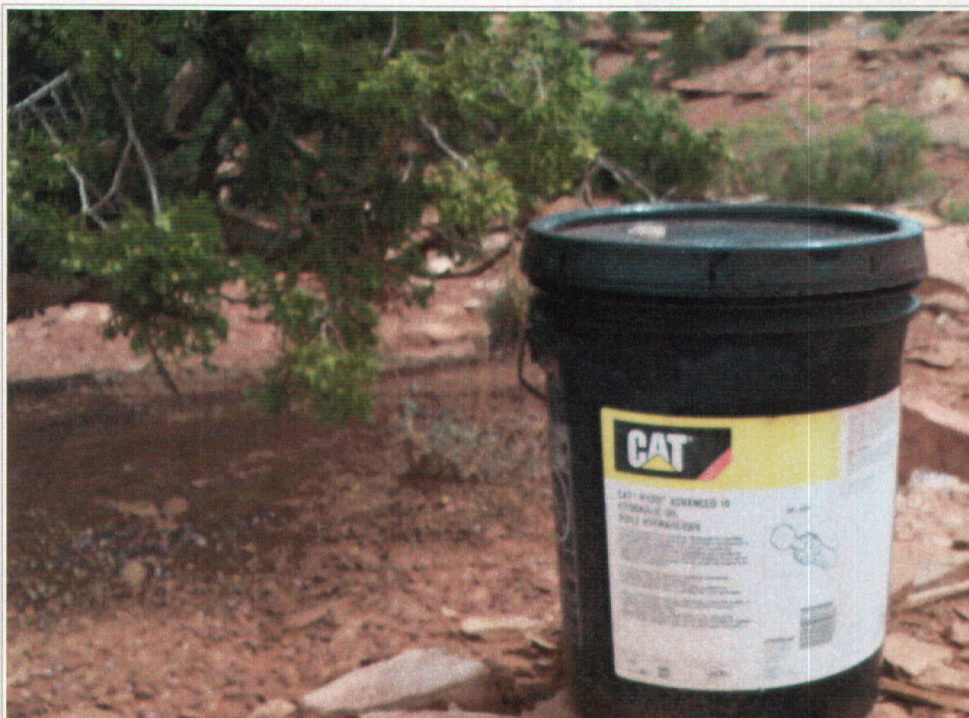
Bucker of hydraulic fluid

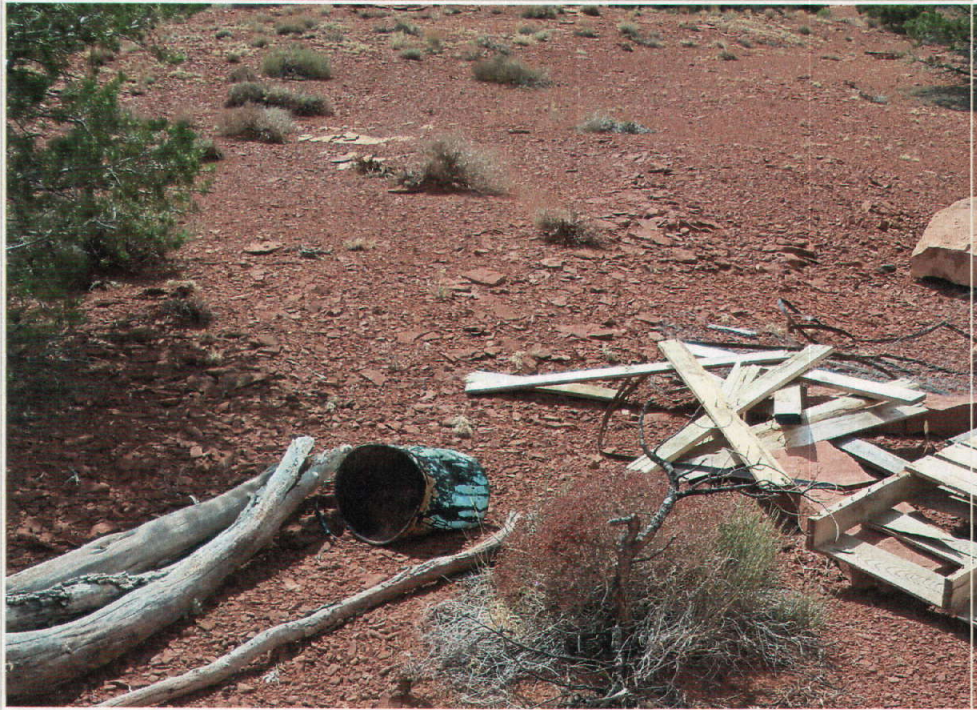
Trash on site

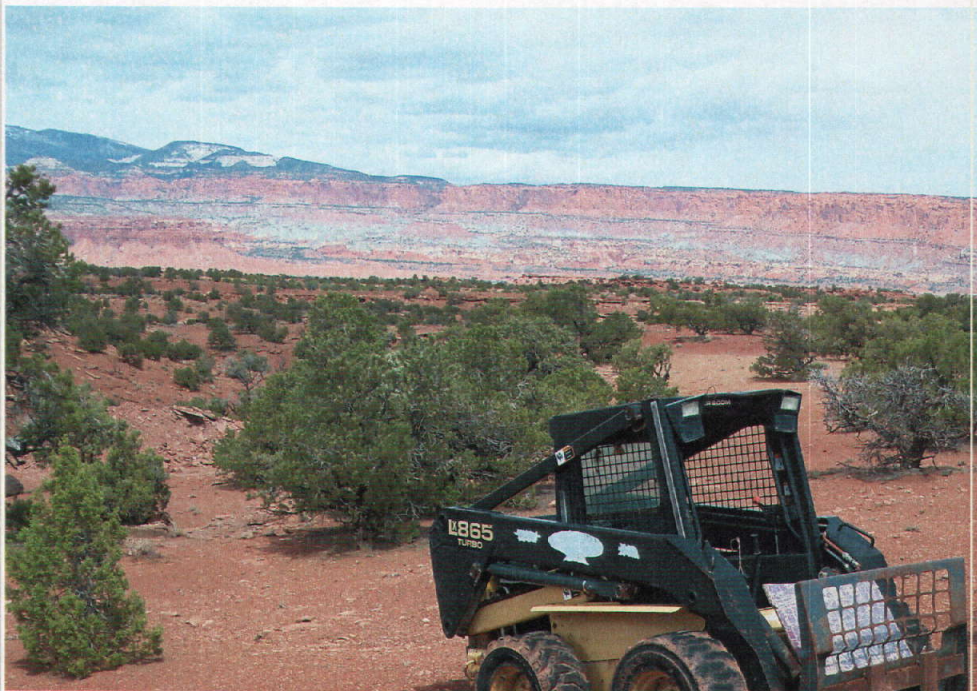
Equipment on site
